UNDERWATER SHIP HUSBANDRY MANUAL

CHAPTER 17 INSPECTION PROCEDURES

SECTION 6 FFG 7 OLIVER HAZARD PERRY CLASS GUIDED MISSILE FRIGATE UNDER-WATER SHIP HUSBANDRY INSPECTION PROCEDURES

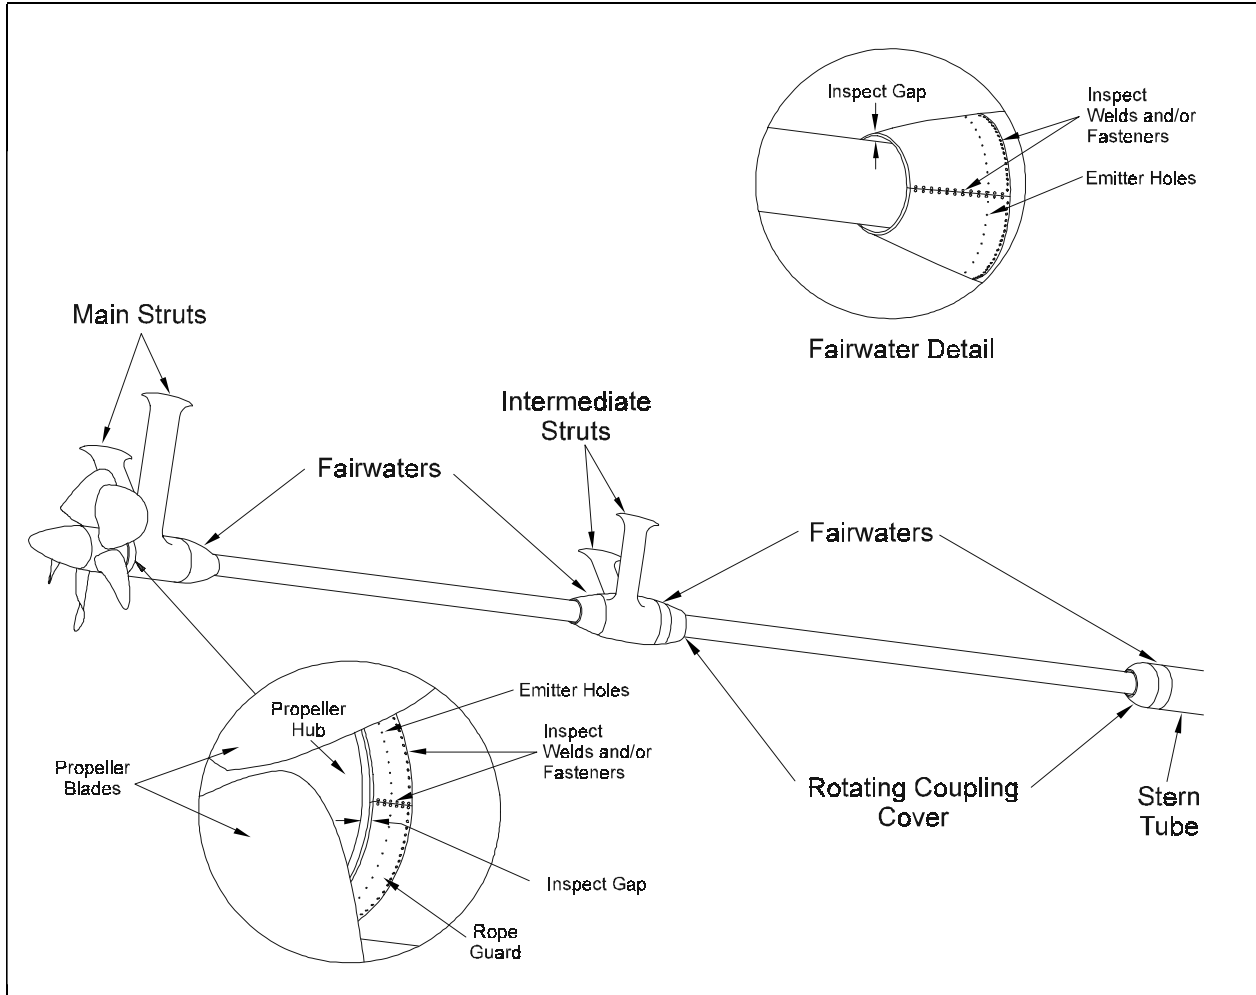
Figure 17-8.5. Main Strut, Intermediate Strut, Shaft, Stern Tube, Rope Guard and Fairwaters.

17-8.4.5 Main Propulsion Assembly (Main Strut, Intermediate Strut, Shaft, Stern Tube, Rope Guard, and Fairwaters).

- (a) Inspect for any apparent damage and for the presence of fouled wire, rope, or other foreign material.
- (b) Verify that the gap between the fairwater and the shaft is uniform all around by taking clearance measurements at the 3, 6, 9, and 12 o'clock positions. Design clearance is not less than 1/4 inch.
- (2) Inspect and report the FR and the PDR of the stern tube, immediate hull plate area, and fairwater.
- (3) If any discrepancies are found, make the appropriate report and arrangements for follow-on repair.

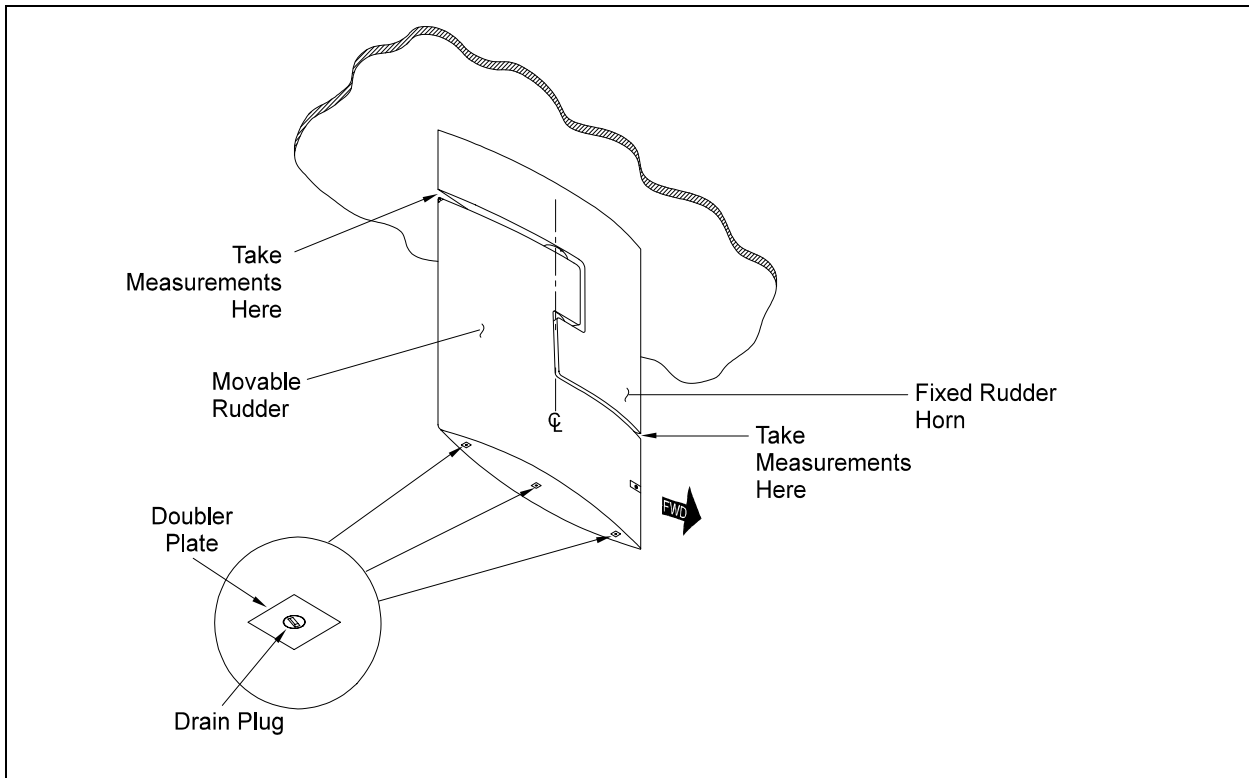
Figure 17-10.3. Semi-Balanced Rudder.

17-10.4.3 Rudder and Rudder Horn Fairwater.

Internal framing and stiffeners will change the sound. It is necessary to sound the rudder and skeg fairwater in different locations. A hollow sound indicates the rudder or horn is not flooded, while a dull sound indicates flooding.

- (2) If the rudder or horn is found to contain water, conduct a detailed inspection to locate the source of flooding. Inspect all plugs for tightness and inspect weld seams for cracks. Make the appropriate report and arrangements for follow-on dewatering and repair.

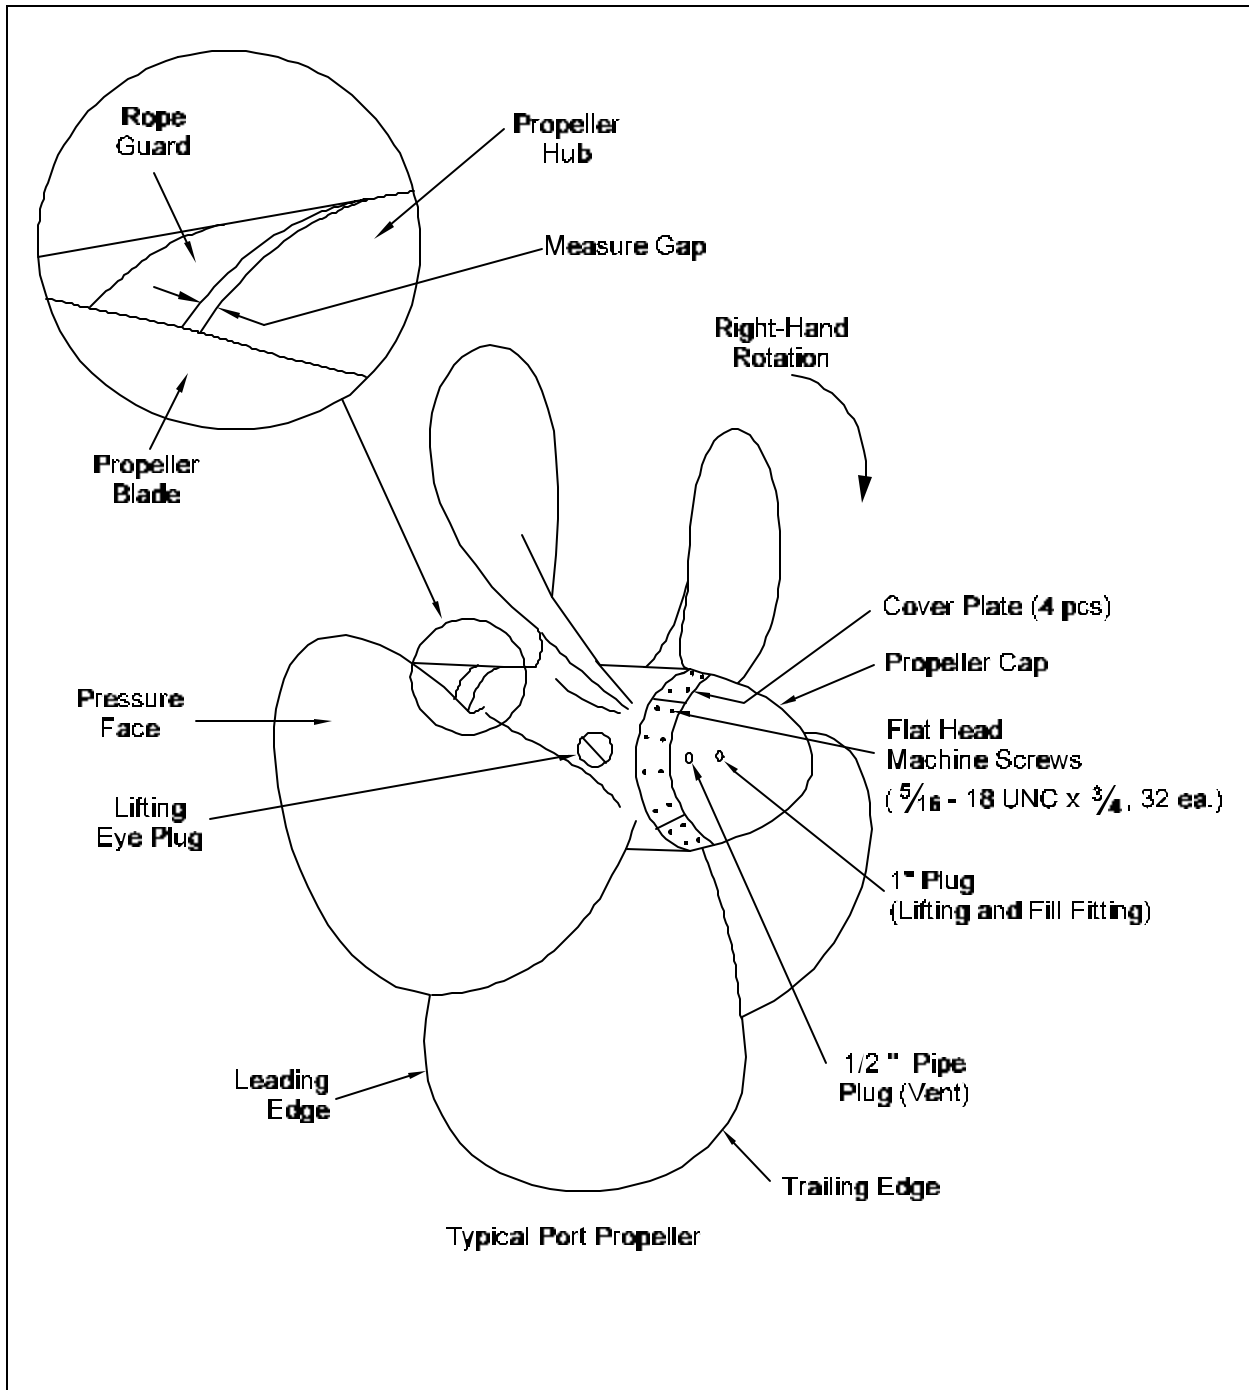
Figure 17-10.4. Fixed-Pitch Propeller.

17-10.4.4 Propeller.

e. Record the overall FR of the propeller.
